Prepared by:
Inspector

433 New Karner Rd
Albany, NY, 12205

General Information

Company Name: Blue Jay Inspections, LLC

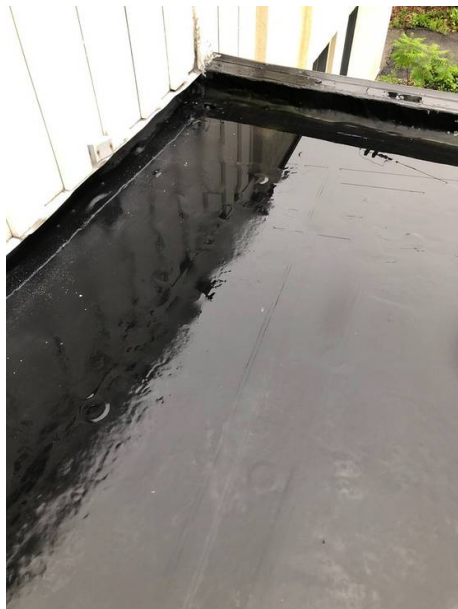
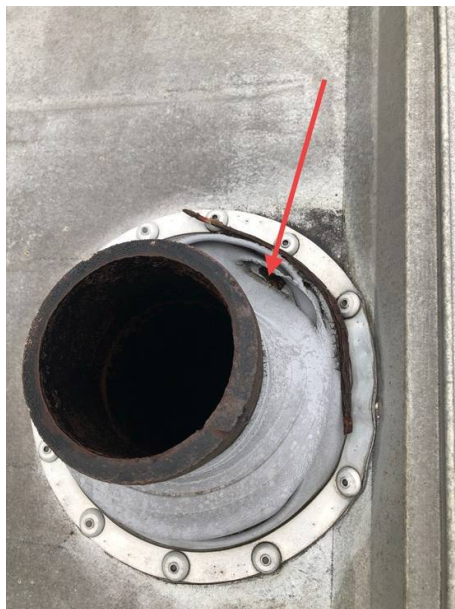
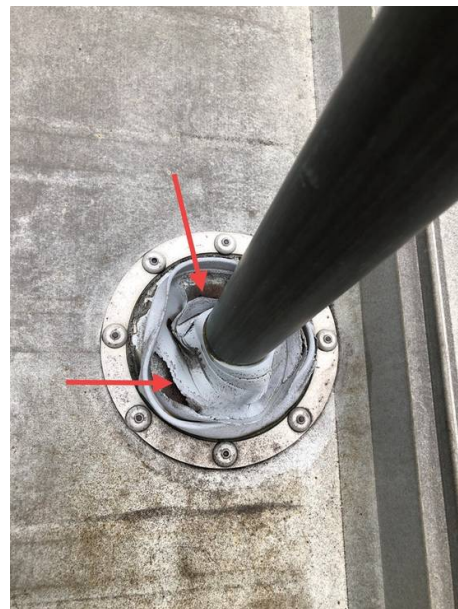
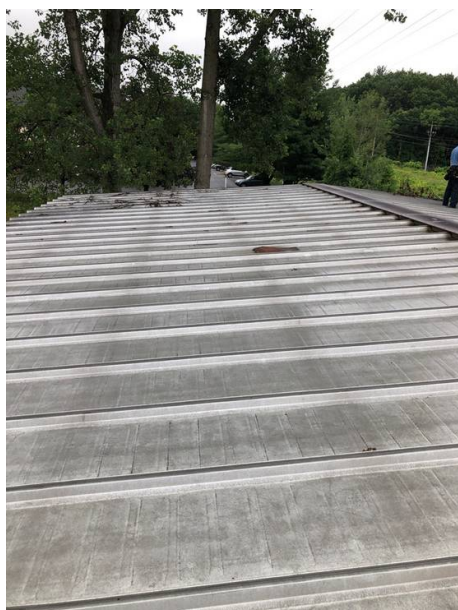
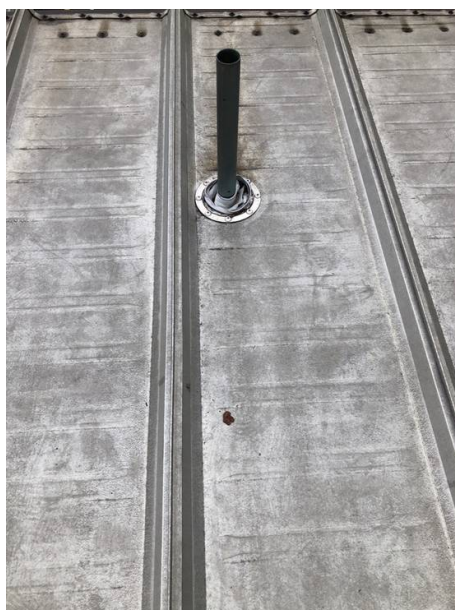
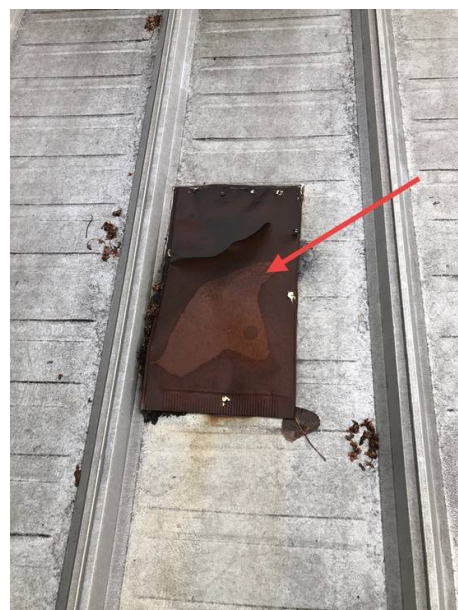
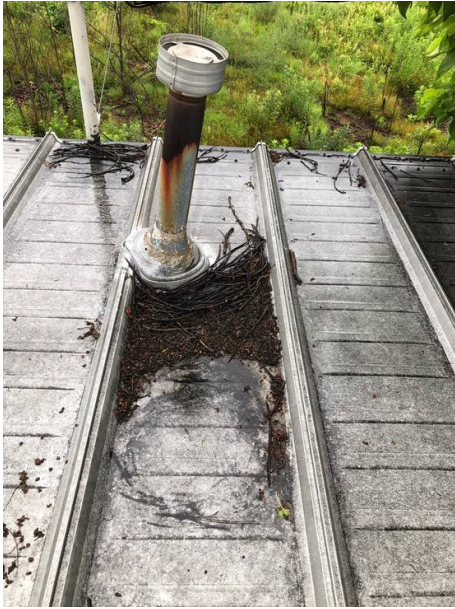
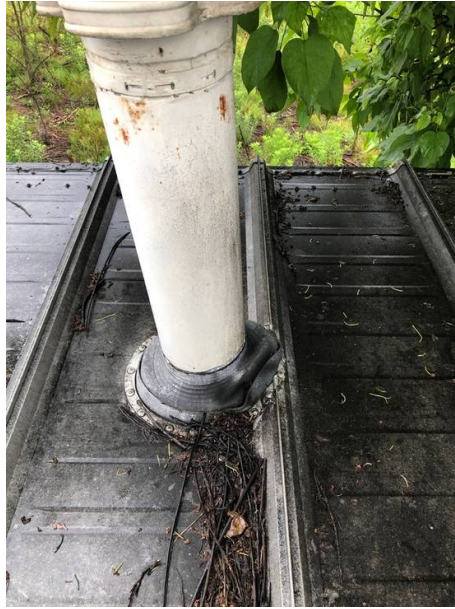
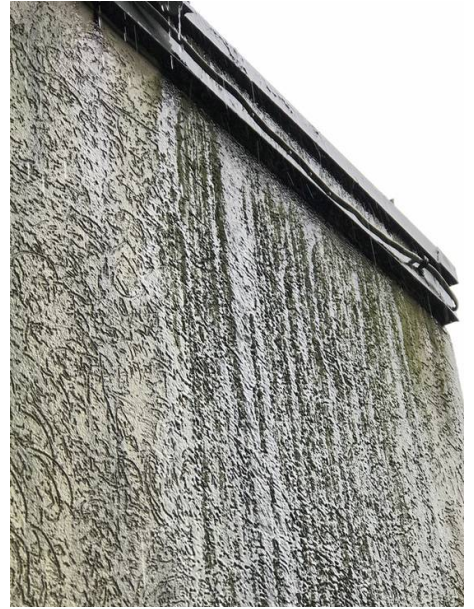
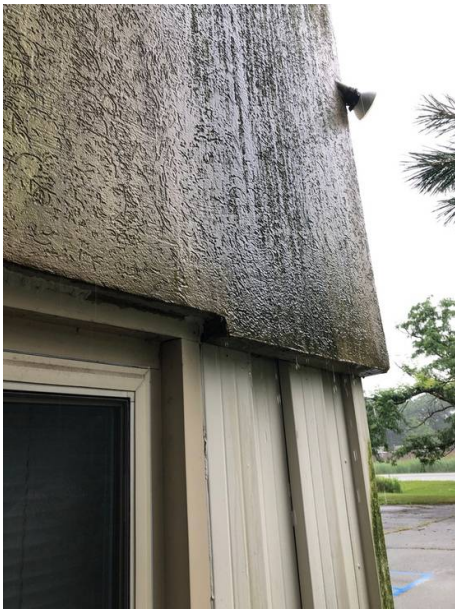
The actual age of the roof was unknown, but indications of leaking were present along the eaves, at the gable ends, and around the penetrations. Water appeared to be coming out of sections of the fascia and flashing, and possibly into the walls and paneling. Improper repairs were noted, damaged sections, improper flashing methods, and other issues. Unseen damage likely exists. Recommend evaluation of the roof and any damage by a qualified roofing contractor.

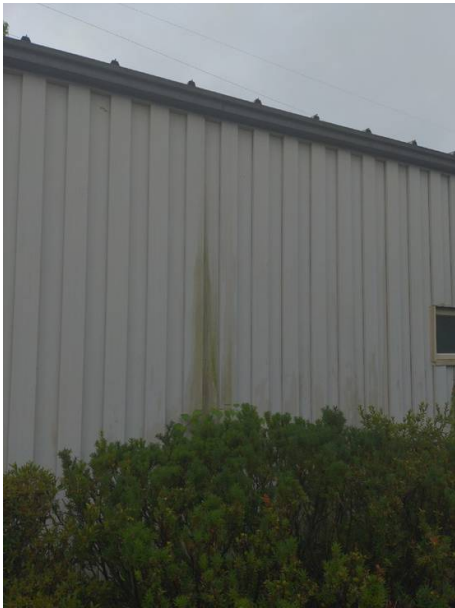
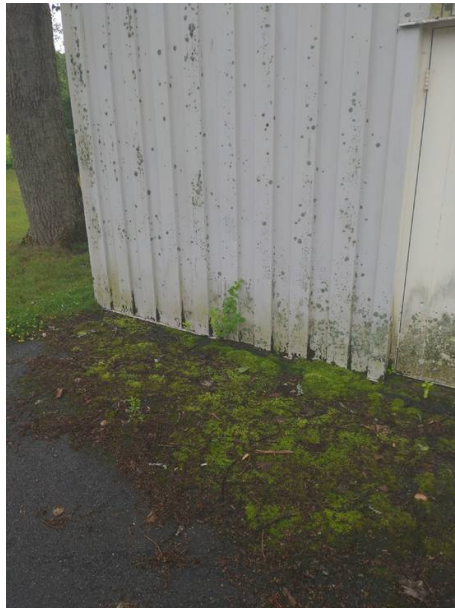
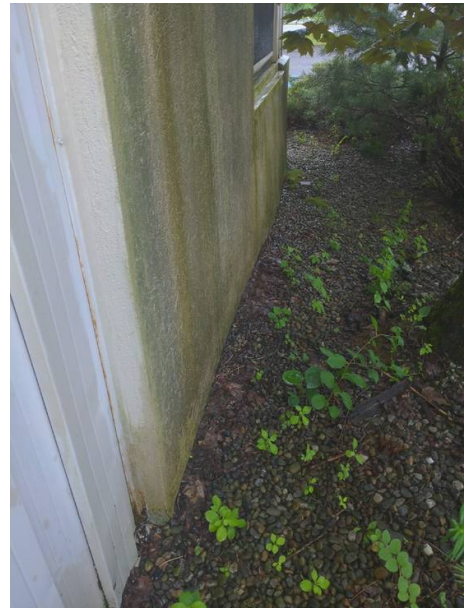
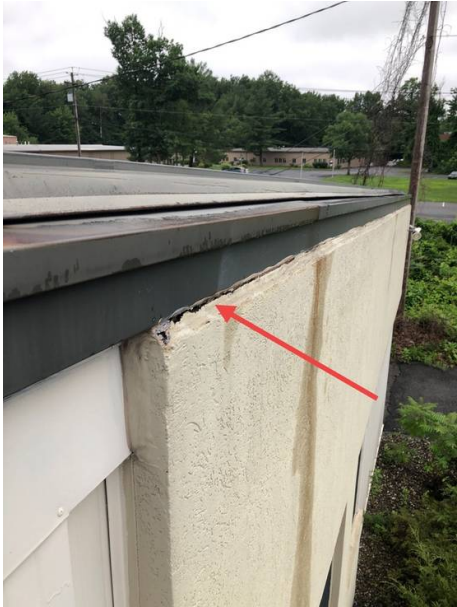
The building appeared to be constructed of insulated panels and steel frame construction. Evidence of active water intrusion into the panels was found in multiple locations from flashing details around windows and door and fascia transitions. Evidence of water intrusion was found on interior walls as well as around window and door frames. Once panels get wet they may not be able to properly dry and internal damage was likely present that would only be discovered with intrusive investigation beyond the scope of this inspection so profession evaluation is recommended by contractors that represent you.

EIFS siding was present on parts of the building and was loose, damaged, and showed signs of moisture intrusion- EIFS exterior finishes are prone to water infiltration and may cause hidden damage to the structure. There is usually no visible evidence of such damage. We recommend a detailed inspection by a qualified specialist.

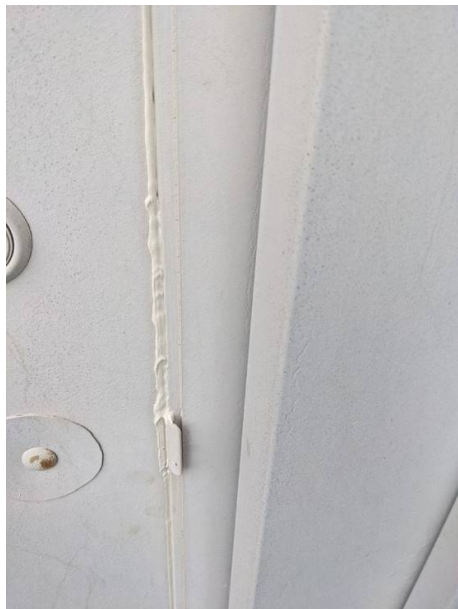
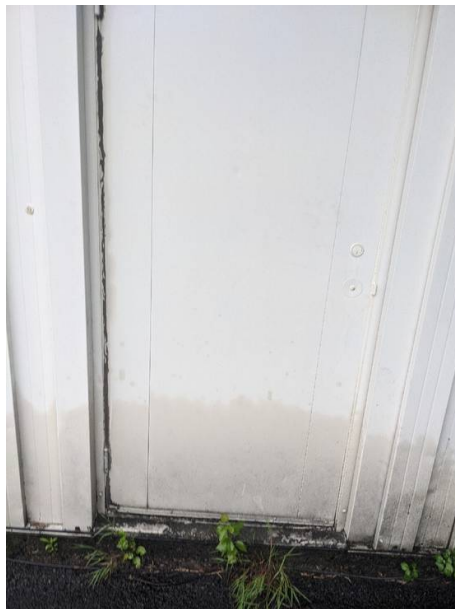
Side exterior door was sealed off a time of inspection. A proper direct emergency egress was not able to be found and is a safety issue

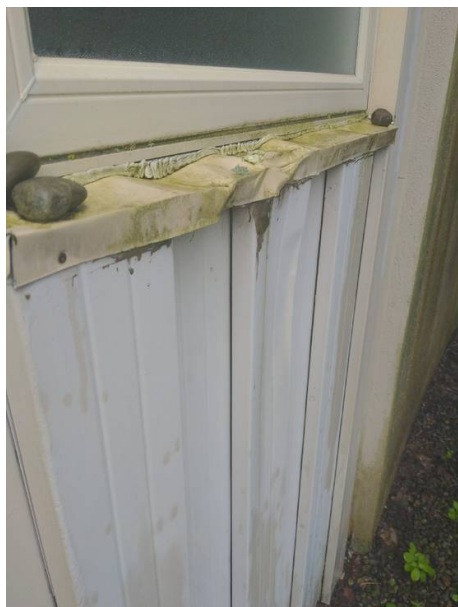
Heavily damaged - see main siding notes

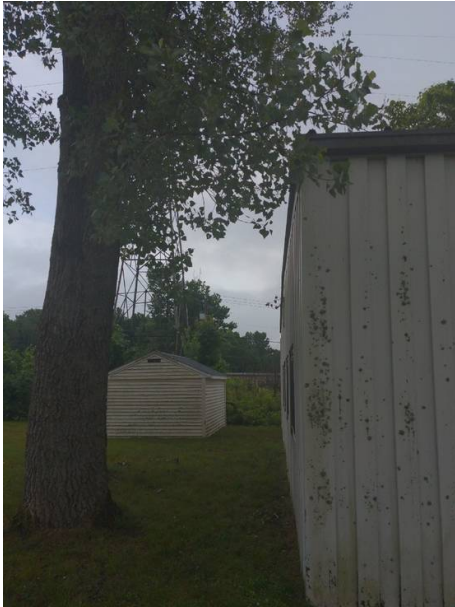
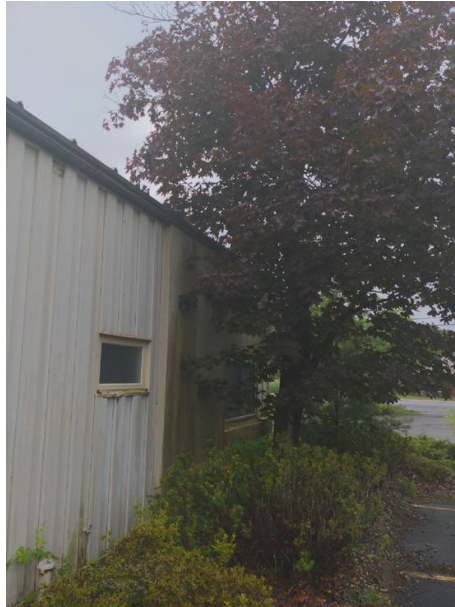
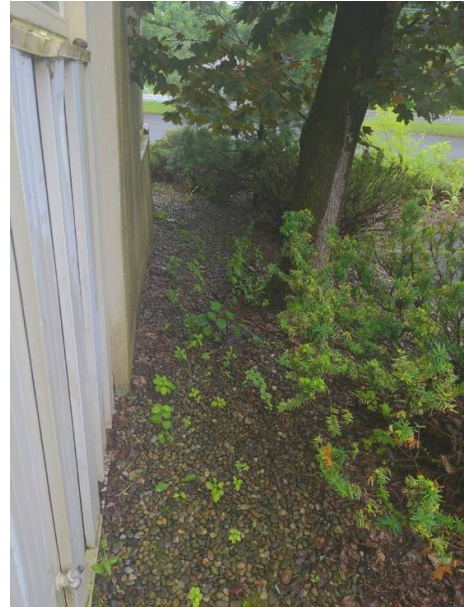
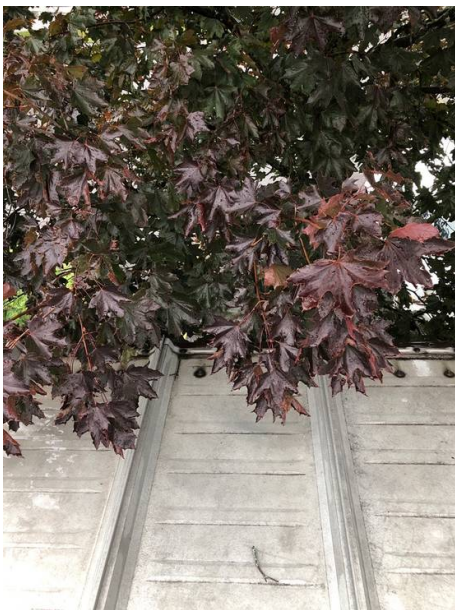
Trees and vegetation were notably close to the building. The roots, branches, and other vegetation appear to be causing issues, and unseen damage likely exists. Recommend evaluation by qualified contractor.

Recommend keeping vegetation away from the structure(s)

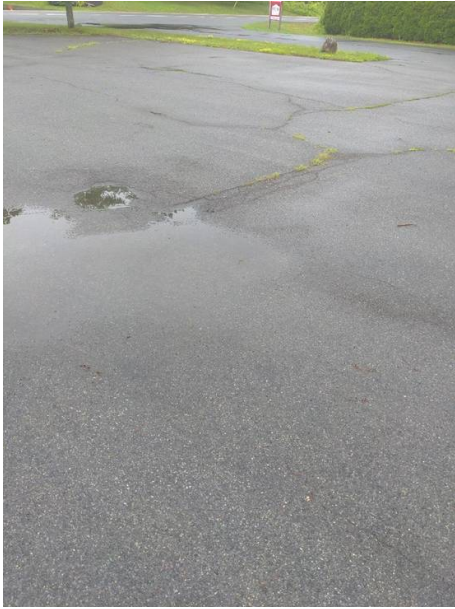
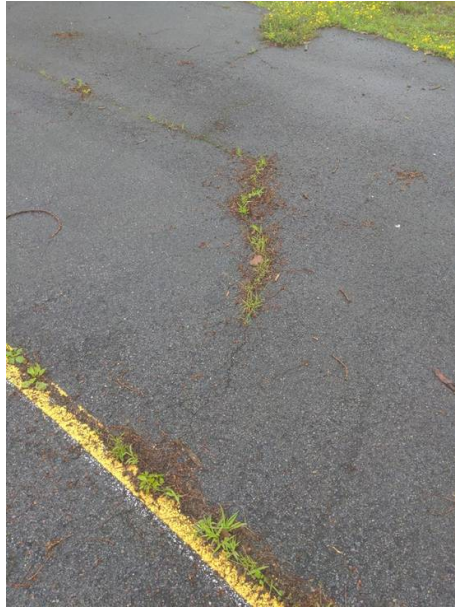
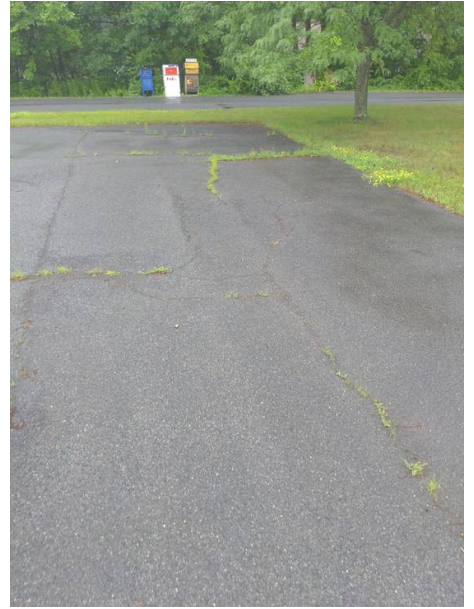
Heavy cracks were noted in the parking lot. The parking lot was notably cracked and had depressions in it. Work will need to be done to continue to keep the parking lot in a usable condition.

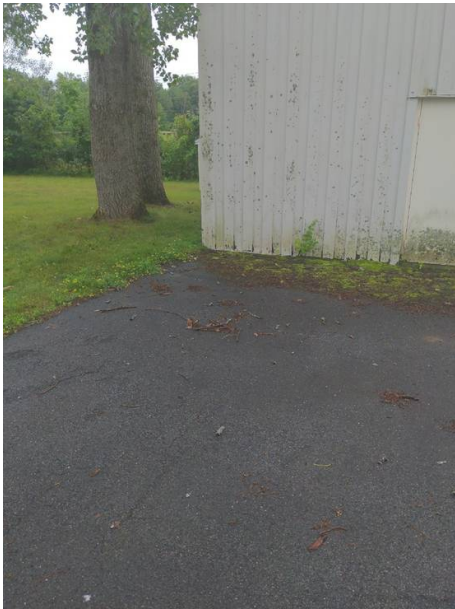
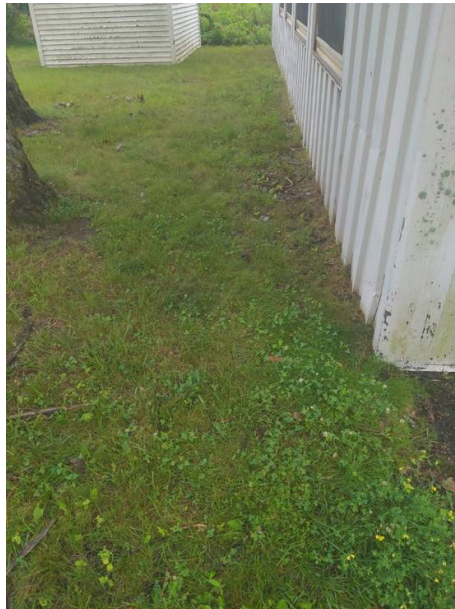
Grading had negative slope in some areas close to home and water could pool against the foundation or cause moisture intrusion

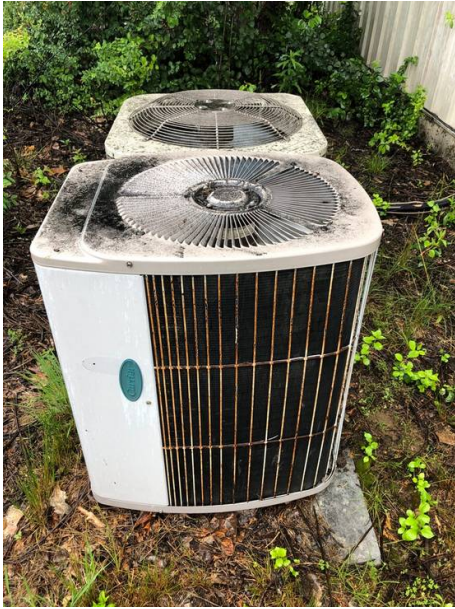
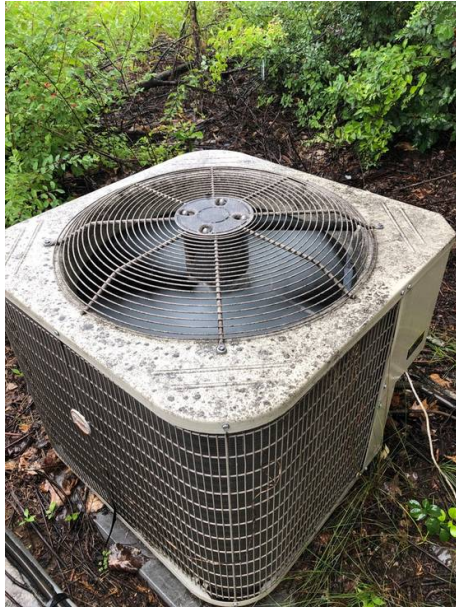
Two air conditioner units were present and both were operational day of using normal thermostatic controls. Be advised that there was some deterioration in age on the units and we have no way of predicting their lifespan.

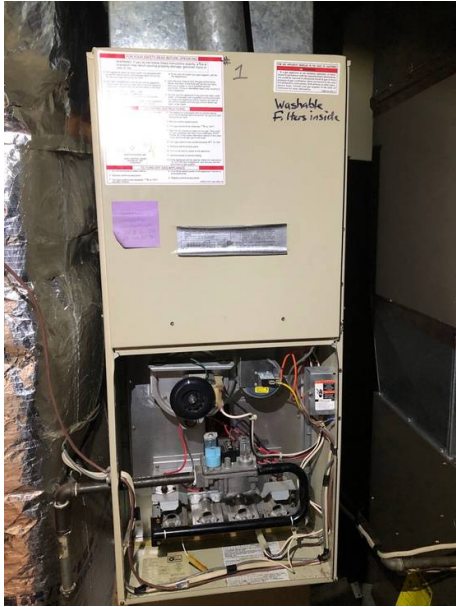
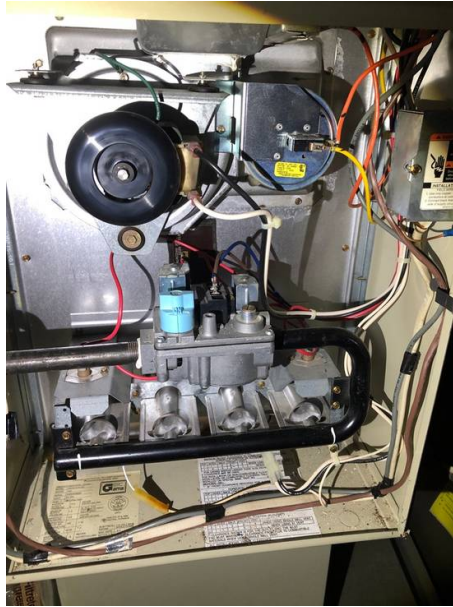
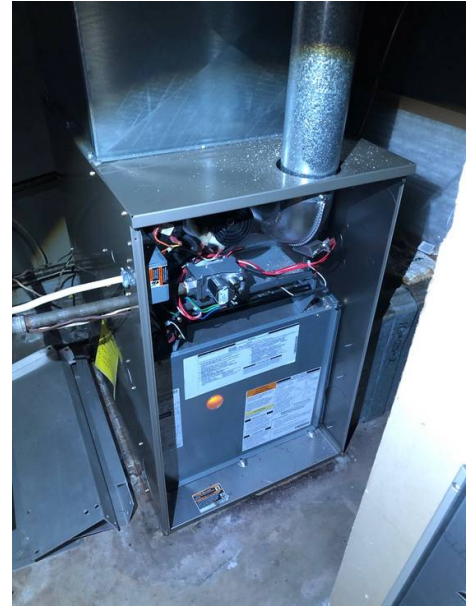
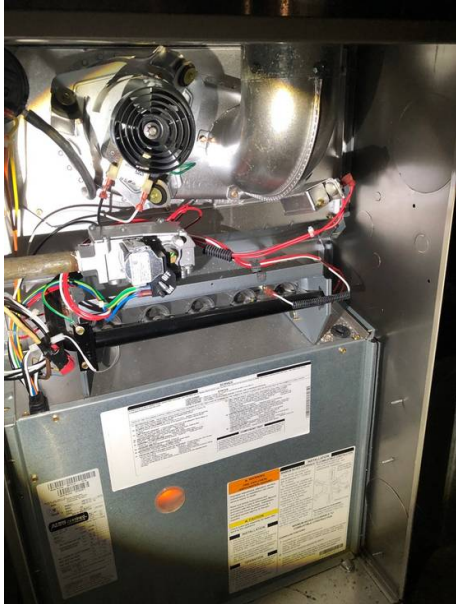
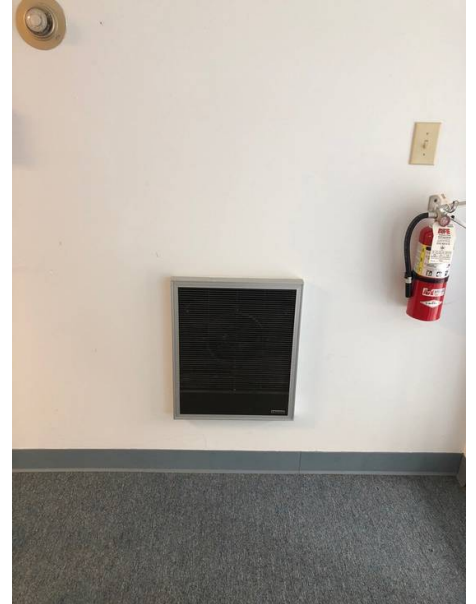
The left unit was operational day of but we suspect the exhaust path was oversized and could be plugging with a thermal stack that's oversized.

The unit to the right did not operate using normal operating thermostats and several attempts were made to reset the unit. A gas smell was present and the unit had power but would not come on. Further evaluation is recommended prior to commitment and we recommed that only qualified professionals that represent your interest be consulted. Any unit that will not operate is suspect till proven otherwise.

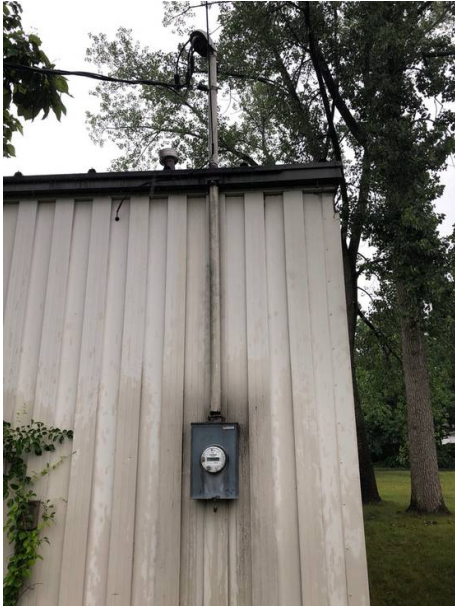
The main service line was too close to a tree, and the main drop was very close to an exhaust pipe for an HVAC system. Evaluation by a qualified contractor is recommended.

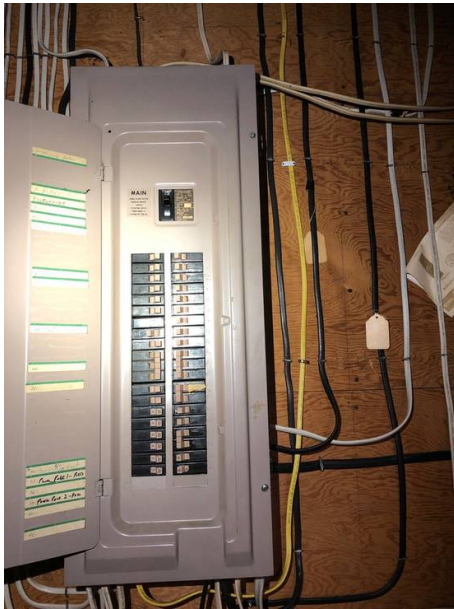
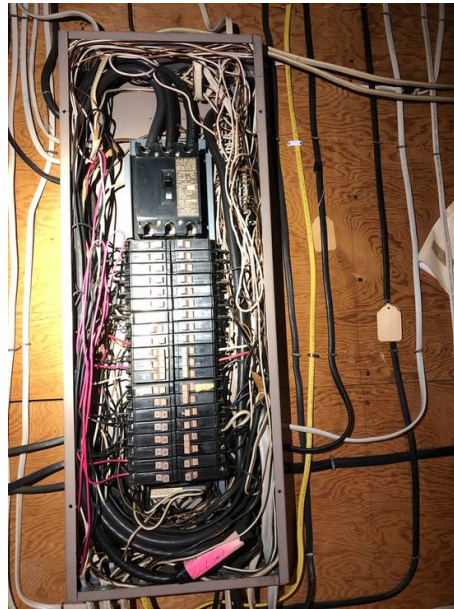
Screws with pointed tips were used that should be replaced with proper electrical screws so the wires are not penetrated and the dead front cover is removed.

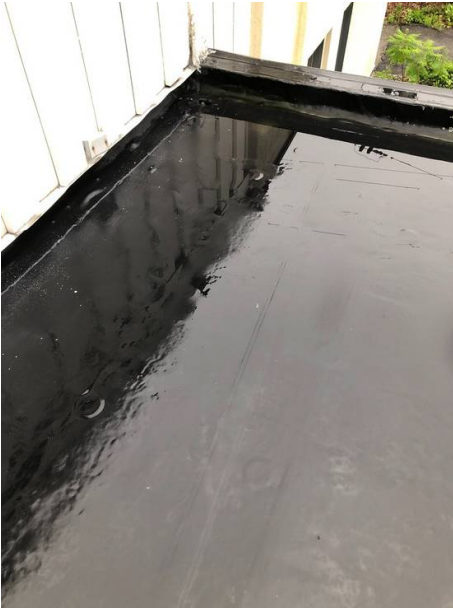
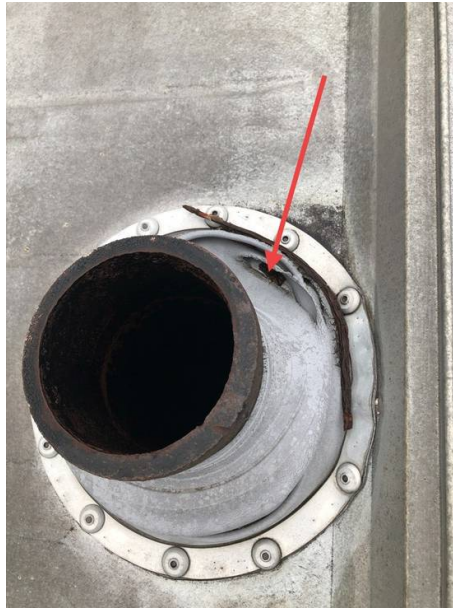
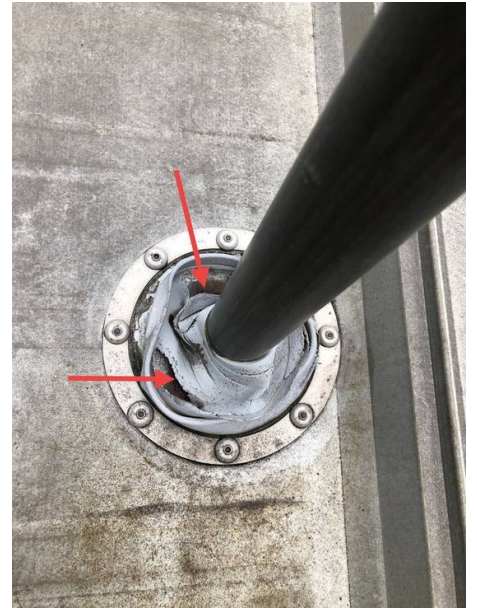
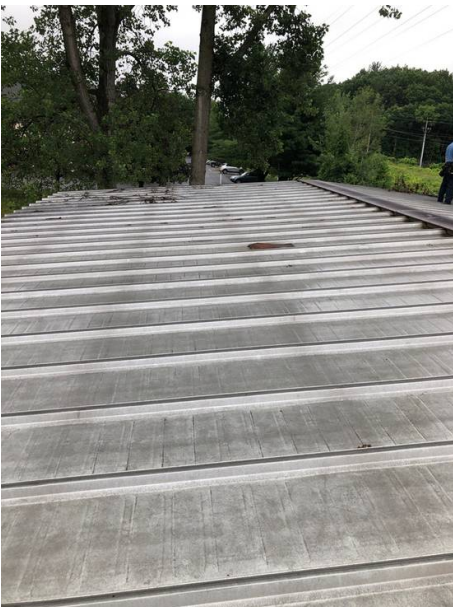
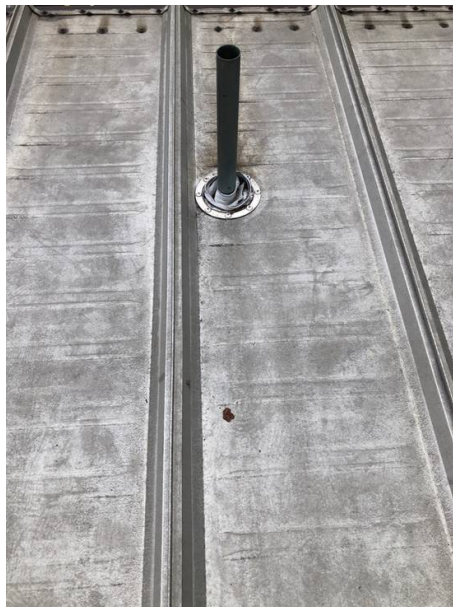
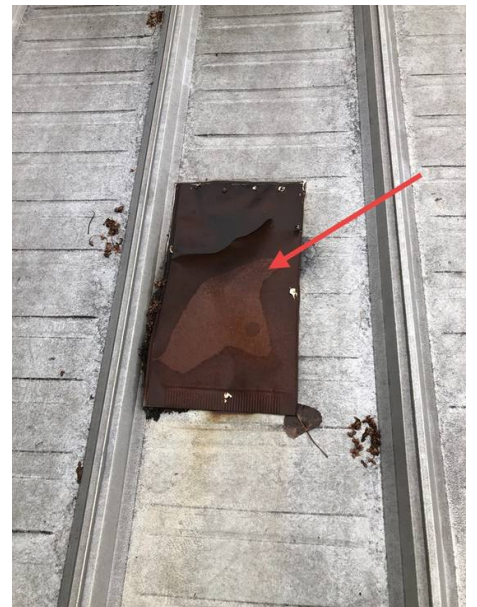
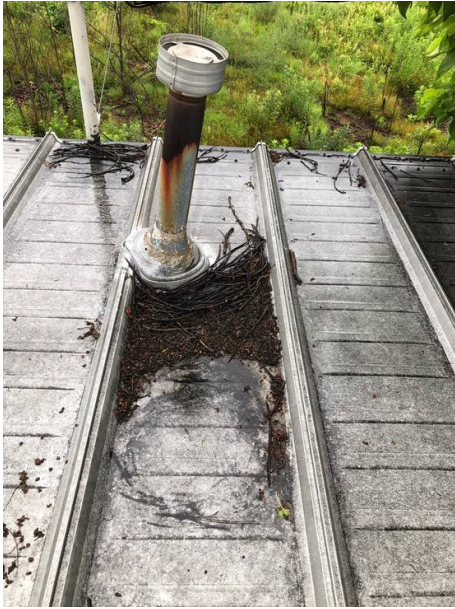
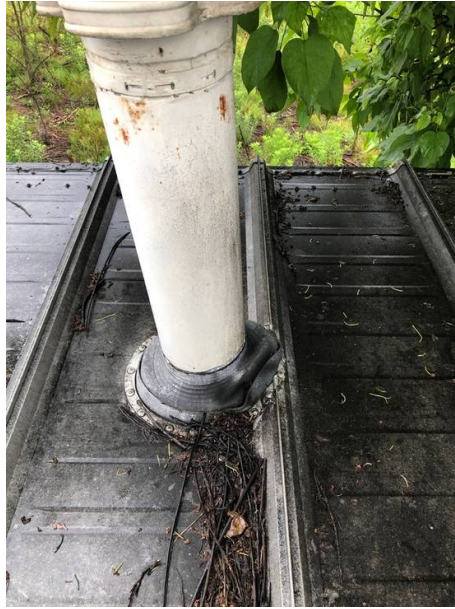
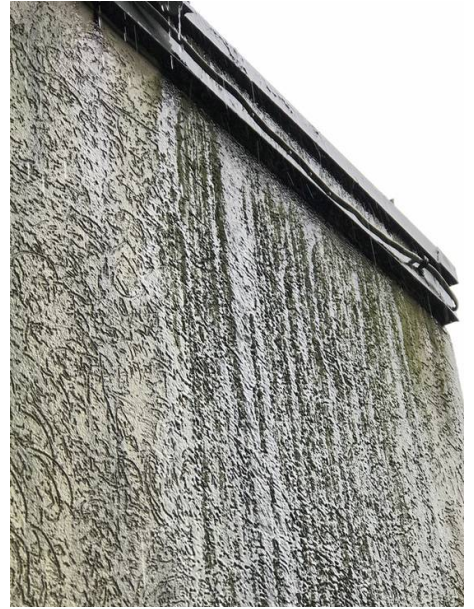
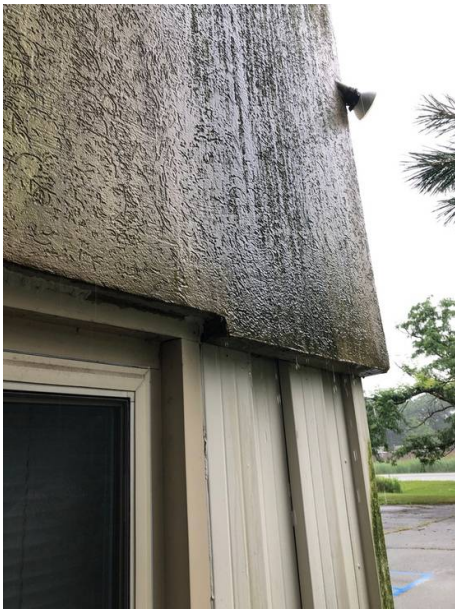
The actual age of the roof was unknown, but indications of leaking were present along the eaves, at the gable ends, and around the penetrations. Water appeared to be coming out of sections of the fascia and flashing, and possibly into the walls and paneling. Improper repairs were noted, damaged sections, improper flashing methods, and other issues. Unseen damage likely exists. Recommend evaluation of the roof and any damage by a qualified roofing contractor.

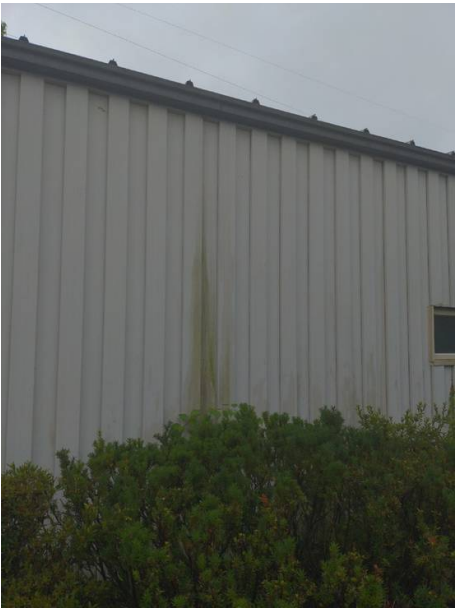
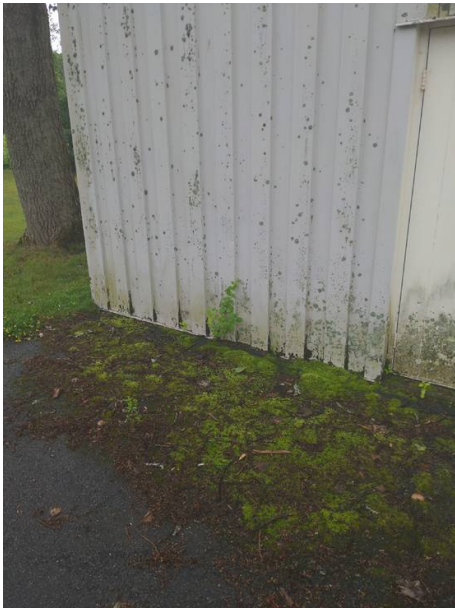
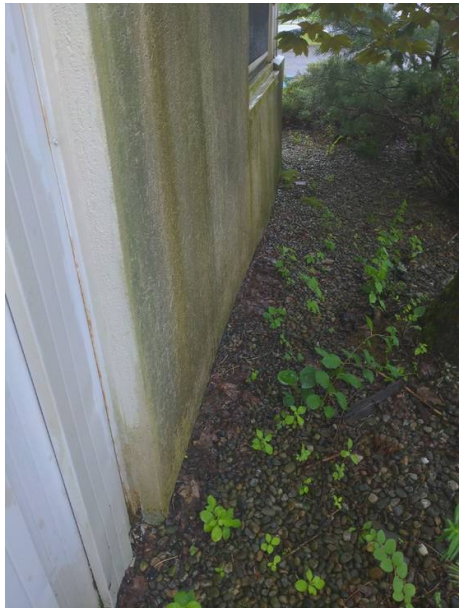
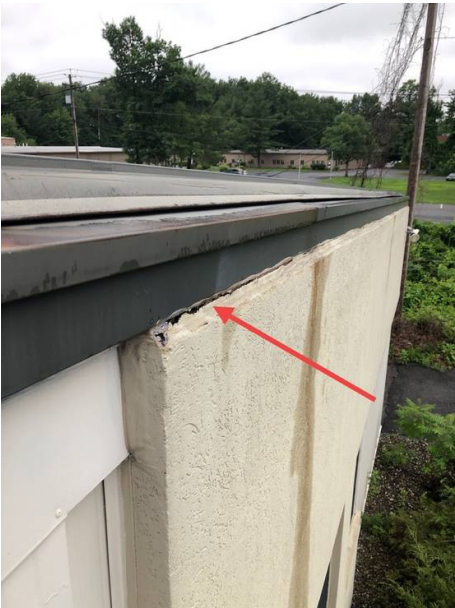
The building appeared to be constructed of insulated panels and steel frame construction. Evidence of active water intrusion into the panels was found in multiple locations from flashing details around windows and door and fascia transitions. Evidence of water intrusion was found on interior walls as well as around window and door frames. Once panels get wet they may not be able to properly dry and internal damage was likely present that would only be

discovered with intrusive investigation beyond the scope of this inspection so profession evaluation is recommended by contractors that represent you.

EIFS siding was present on parts of the building and was loose, damaged, and showed signs of moisture intrusion- EIFS exterior finishes are prone to water infiltration and may cause hidden damage to the structure. There is usually no visible evidence of such damage. We recommend a detailed inspection by a qualified specialist.

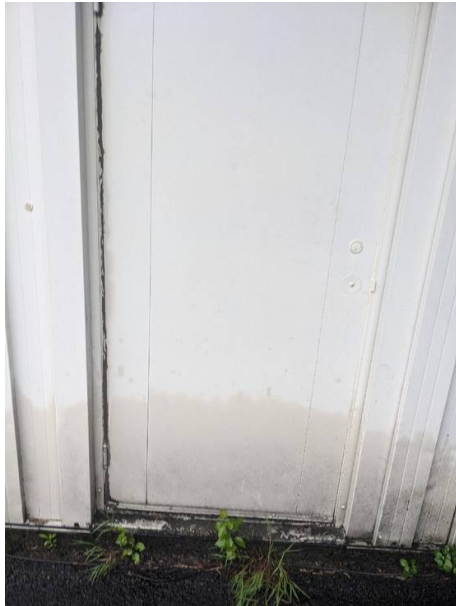
Side exterior door was sealed off a time of inspection. A proper direct emergency egress was not able to be found and is a safety issue

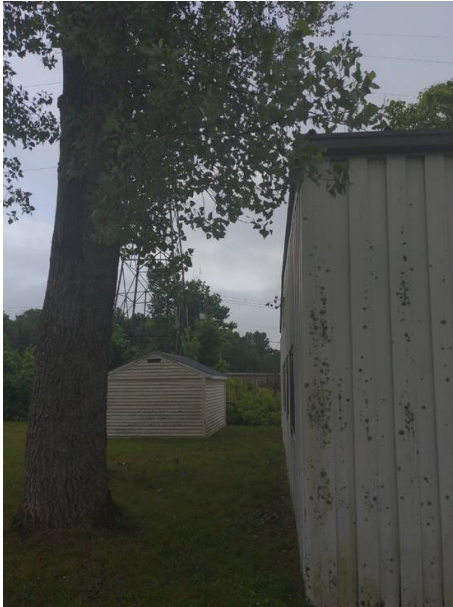
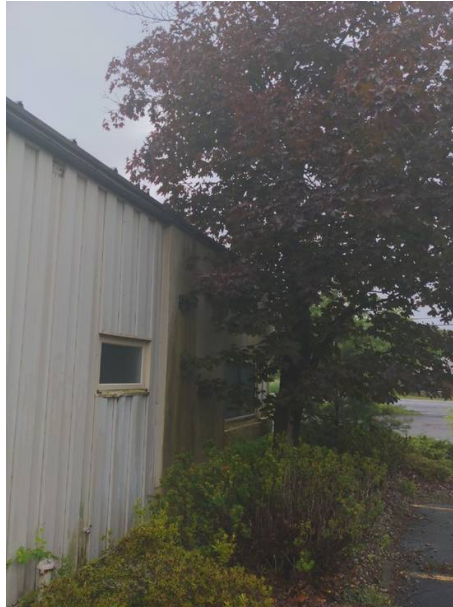
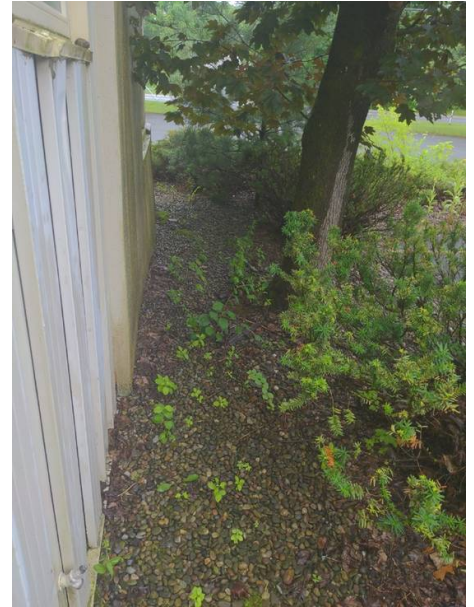
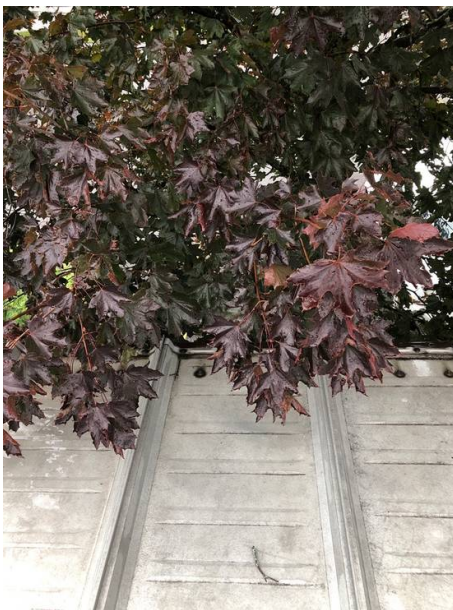
Recommend keeping vegetation away from the structure(s)
Trees and vegetation were notably close to the building. The roots, branches, and other vegetation appear to be causing issues, and unseen damage likely exists. Recommend evaluation by qualified contractor.

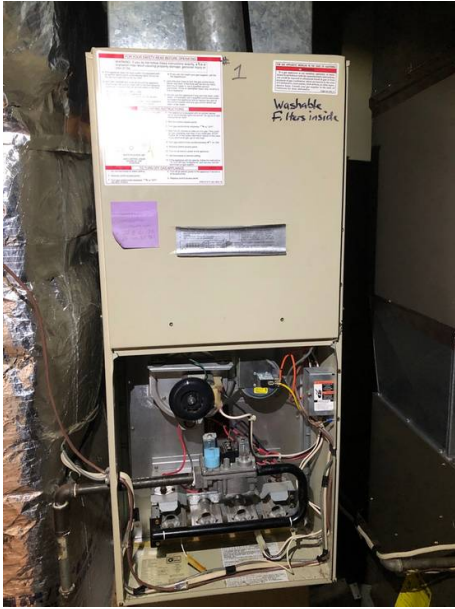
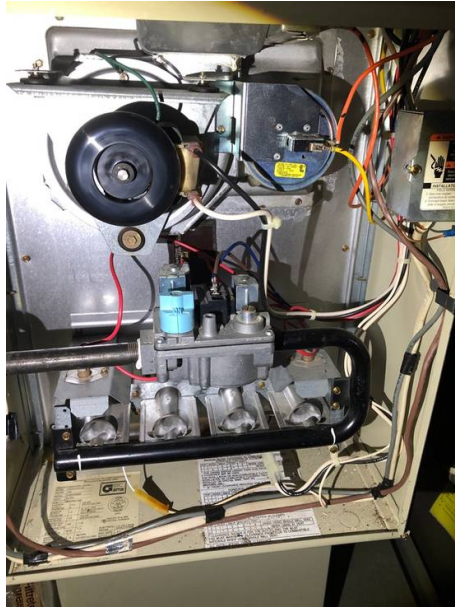
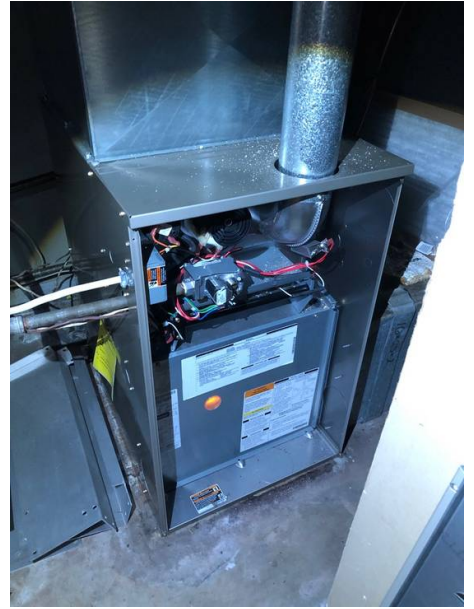
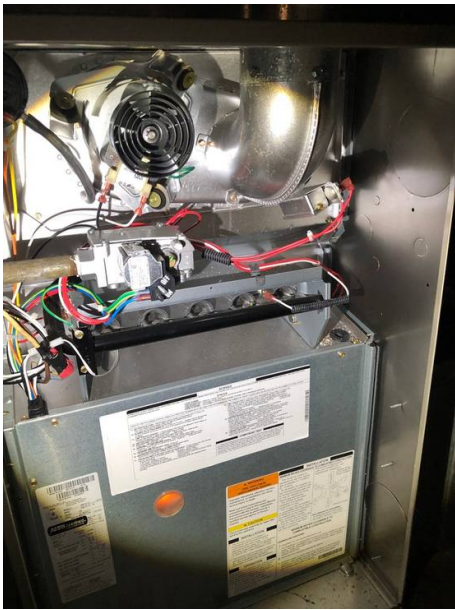
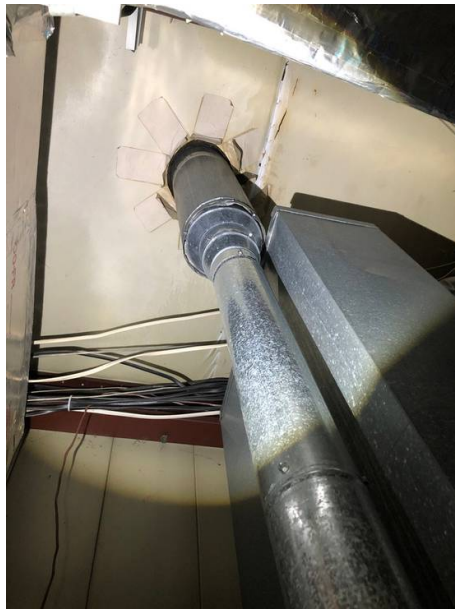
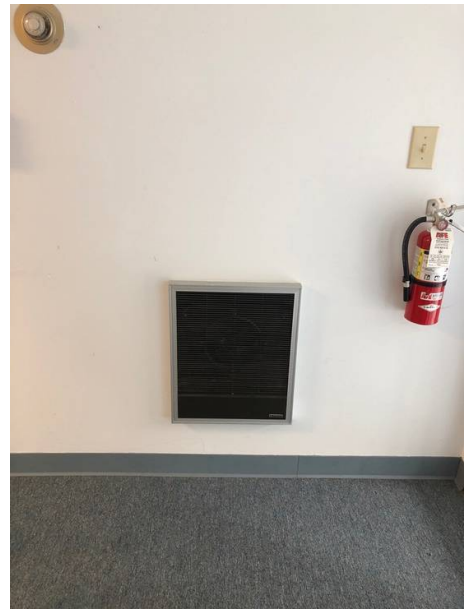
The left unit was operational day of but we suspect the exhaust path was oversized and could be plugging with a thermal stack that's oversized.

The unit to the right did not operate using normal operating thermostats and several attempts were made to reset the unit. A gas smell was present and the unit had power but would not come on. Further evaluation is recommended prior to commitment and we recommend that only qualified professionals that represent your interest be consulted. Any unit that will not operate is suspect till proven otherwise.

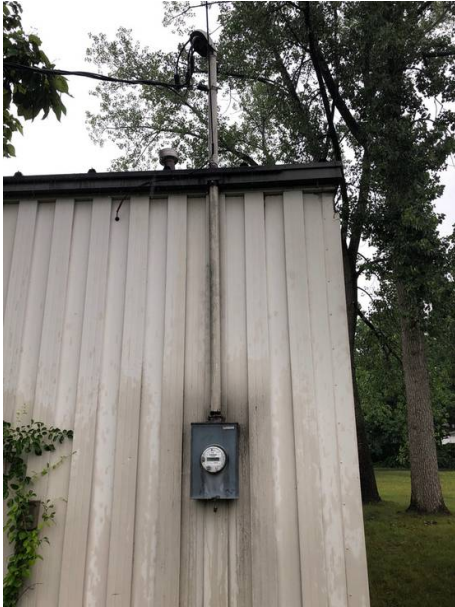
The main service line was too close to a tree, and the main drop was very close to an exhaust pipe for an HVAC system. Evaluation by a qualified contractor is recommended.

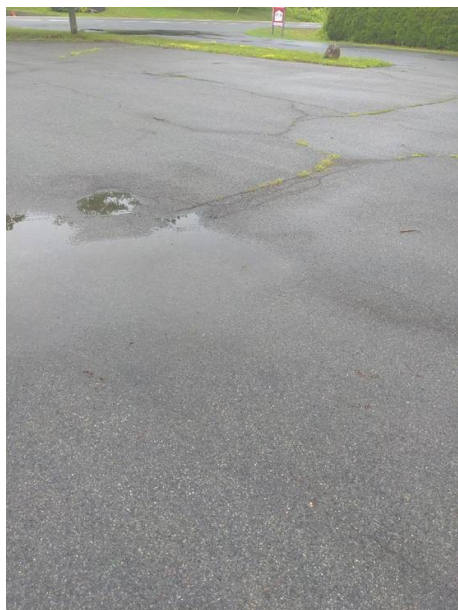
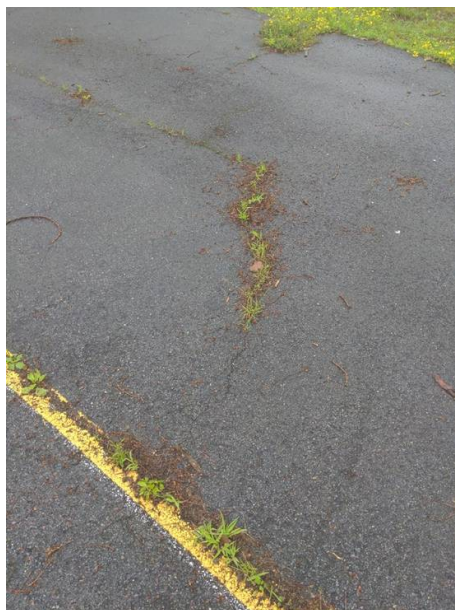
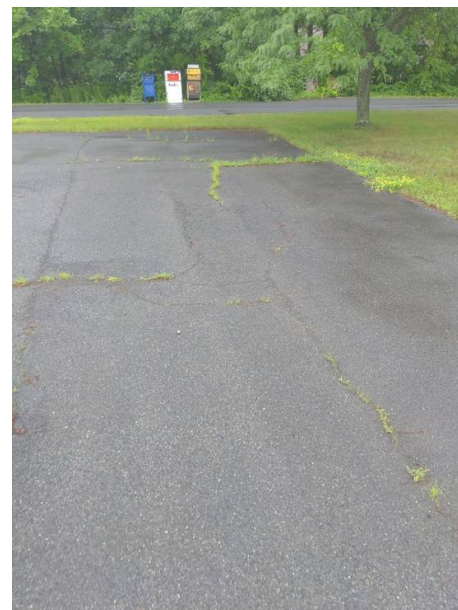
Heavy cracks were noted in the parking lot

The parking lot was notably cracked and had depressions in it. Work will need to be done to continue to keep the parking lot in a usable condition.

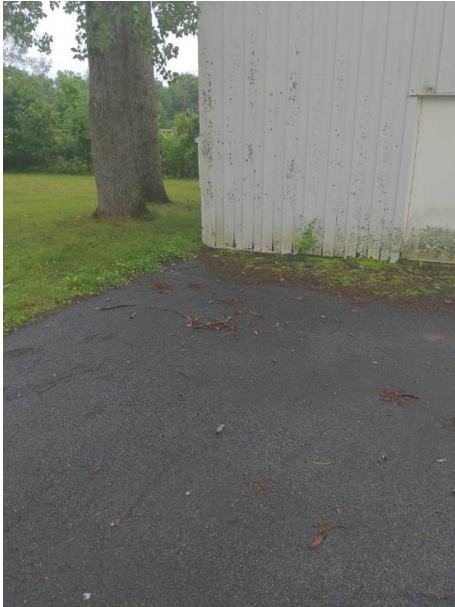
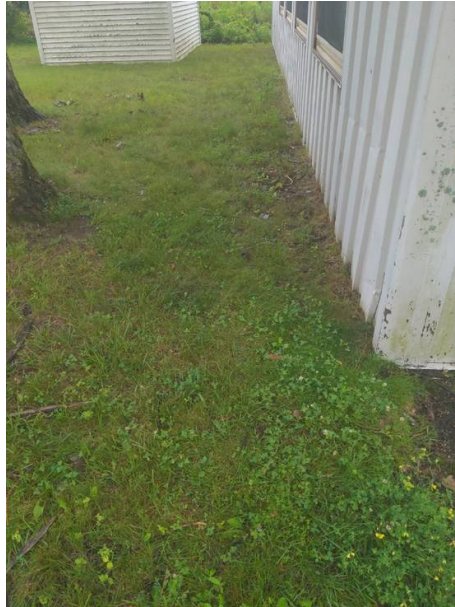
Grading had negative slope in some areas close to home and water could pool against the foundation or cause moisture intrusion

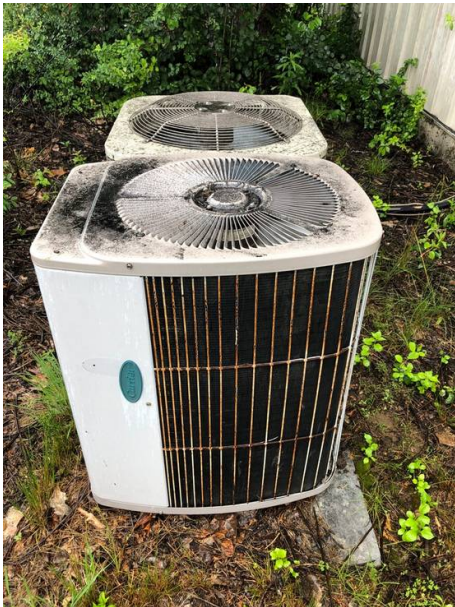
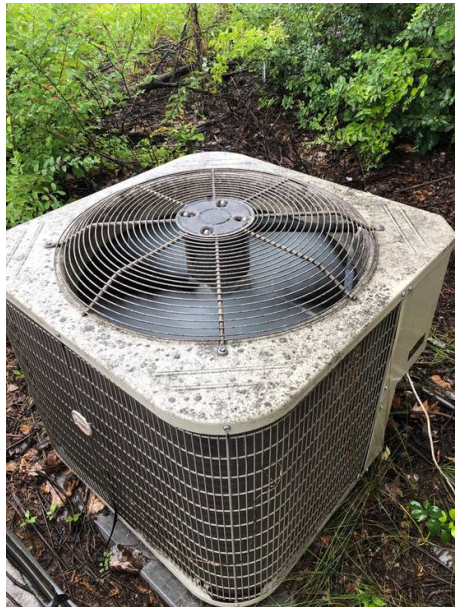
Two air conditioner units were present and both were operational day of using normal thermostatic controls. Be advised that there was some deterioration in age on the units and we have no way of predicting their lifespan.
