Prepared by:
Inspector

433 New Karner Rd
Albany, NY, 12205

General Information

Company Name: Blue Jay Inspections, LLC

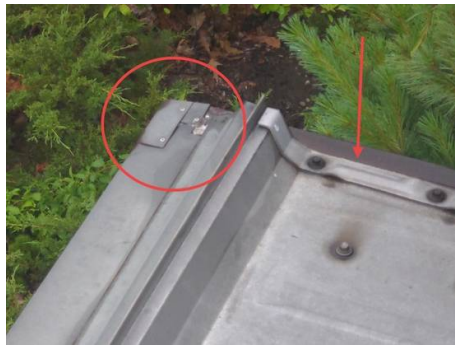
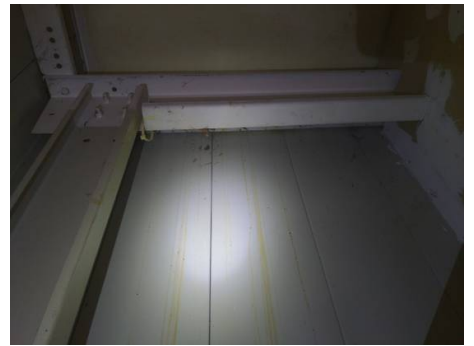
The actual age of the roof was unknown, but indications of leaking were present along the eaves, at the gable ends, and around the penetrations. Water appeared to be coming out of sections of the fascia and flashing, and possibly into the walls and paneling. Improper repairs were noted, damaged sections, improper flashing methods, and other issues. Unseen damage likely exists. Recommend evaluation of the roof and any damage by a qualified roofing contractor.

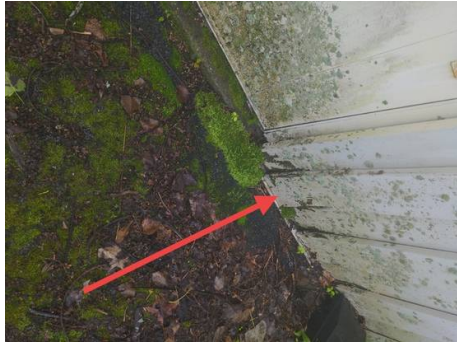
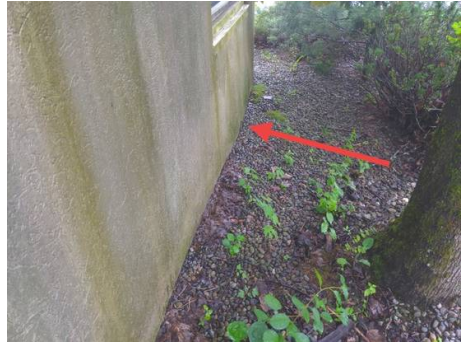
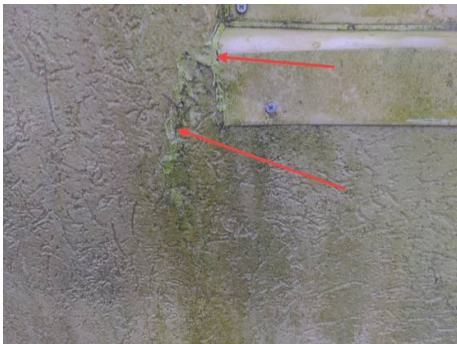
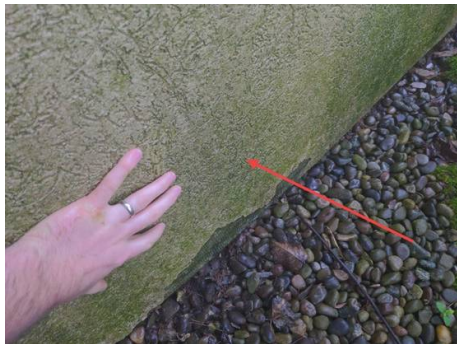
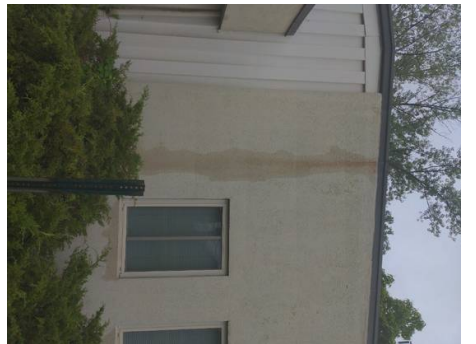
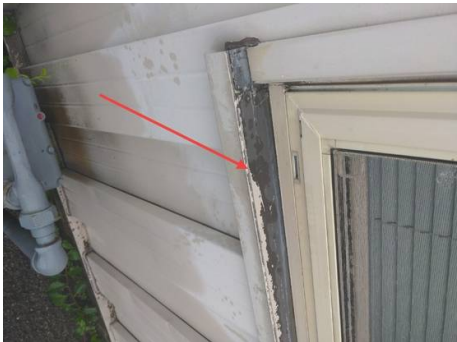
The building appeared to be constructed of insulated panels and steel frame construction. Evidence of active water intrusion into the panels was found in multiple locations from flashing details around windows and door and fascia transitions. Evidence of water intrusion was found on interior walls as well as around window and door frames. Once panels get wet they may not be able to properly dry and internal damage was likely present that would only be discovered with intrusive investigation beyond the scope of this inspection so profession evaluation is recommended by contractors that represent you.

EIFS siding was present on parts of the building and was loose, damaged, and showed signs of moisture intrusion- EIFS exterior finishes are prone to water infiltration and may cause hidden damage to the structure. There is usually no visible evidence of such damage. We recommend a detailed inspection by a qualified specialist.

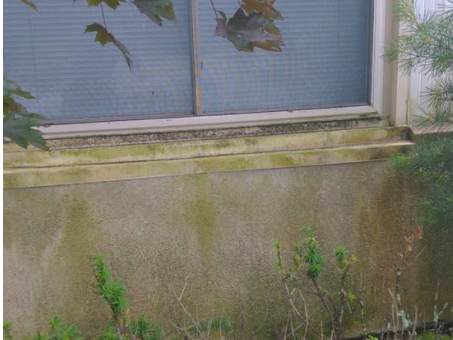
Some windows had hard operation. Damage was also noted around several windows - see main exterior siding notes

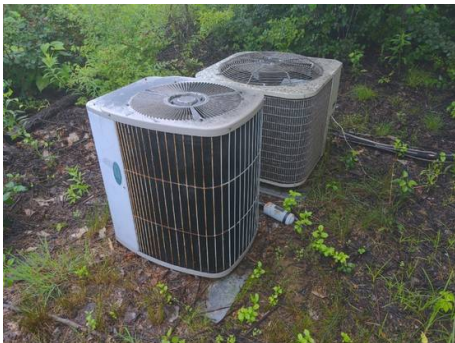
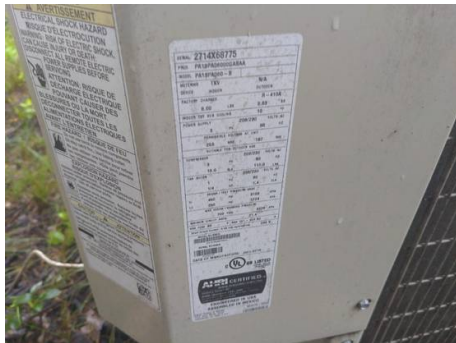
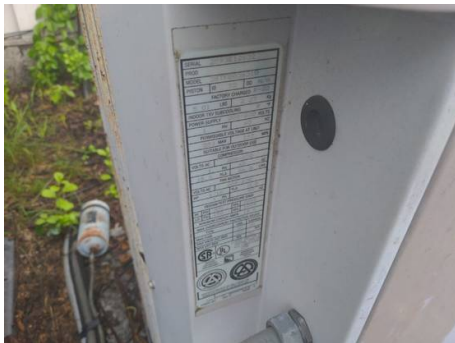
The exterior units were notably deteriorate and in need of maintenance by qualified professional

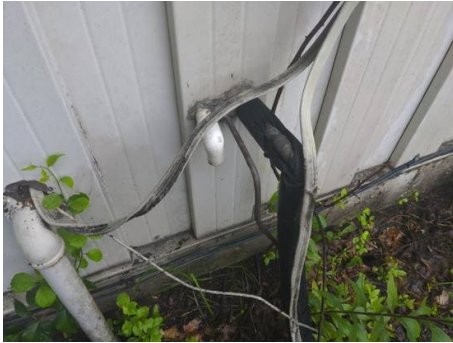
Condensation Removal

Condensation removal did not discharge far enough away from the building

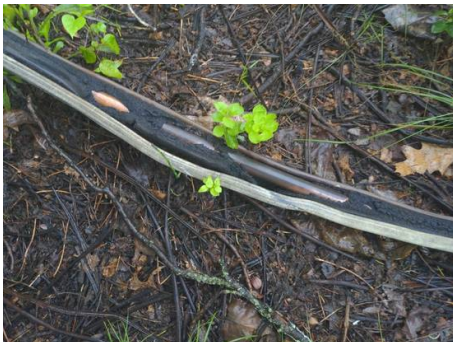
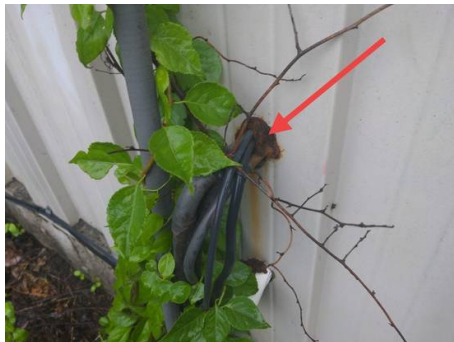
Refrigerant Lines

Deteriorated insulation noted at refrigerant lines
Unsealed entry point of refrigerant lines into the home

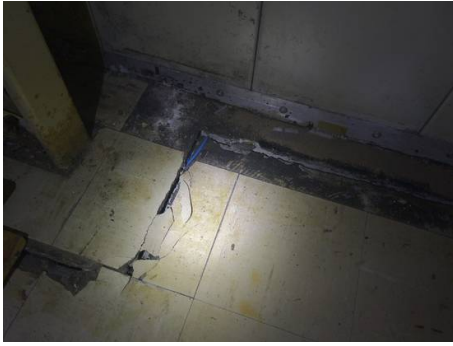
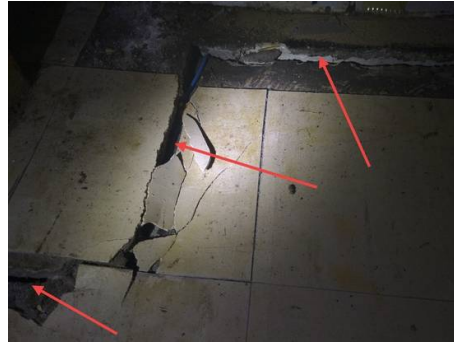
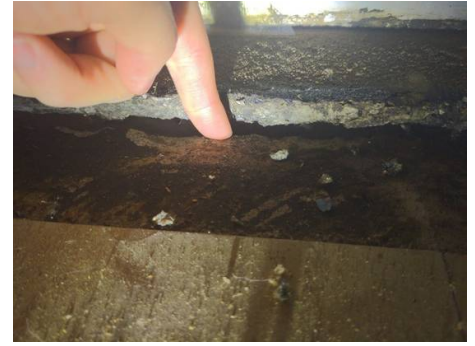
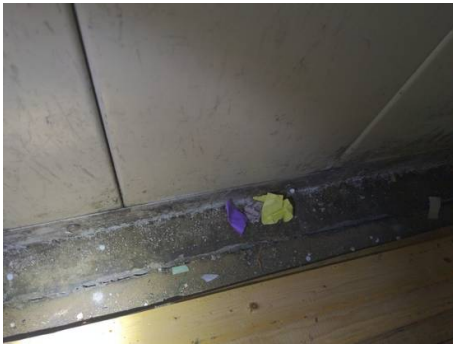
Indications of movement were noted in the slab/supports at the rear of the building. The gaps and indications of movement that were noted were outside of the normal range for a building of this type, and were also at an area with a large tree that was close to the building.
Evaluation of this structure by a qualified structural engineer is recommended

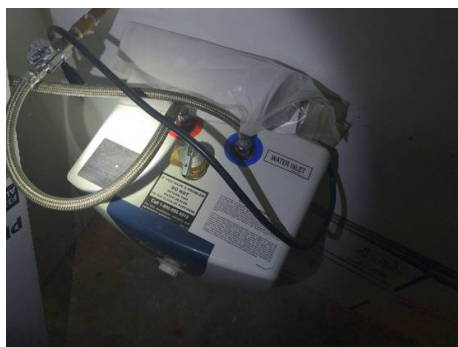
Water heater was not on at time of inspection and was not able to be tested.
Missing drain tube at TPRV

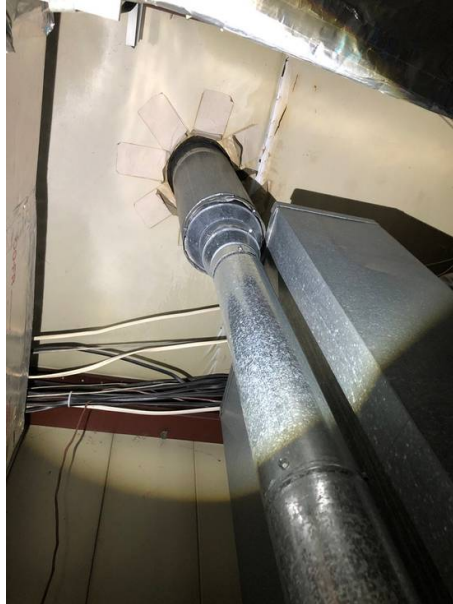
The left unit was operational day of but we suspect the exhaust path was oversized and could be plugging with a thermal stack that's oversized.

The unit to the right did not operate using normal operating thermostats and several attempts were made to reset the unit. A gas smell was present and the unit had power but would not come on. Further evaluation is recommended prior to commitment and we recommed that only qualified professionals that represent your interest be consulted. Any unit that will not operate is suspect till proven otherwise.

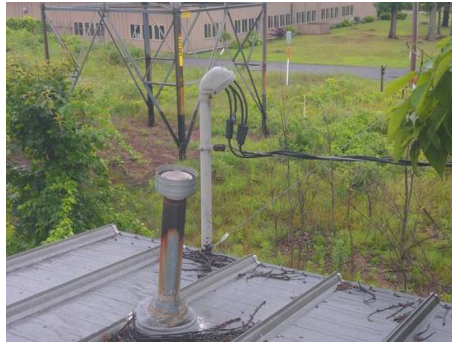
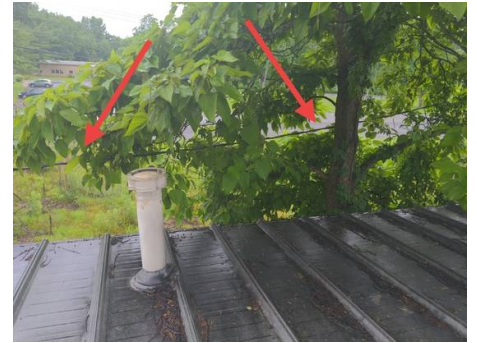
The main service line was too close to a tree, and the main drop was very close to an exhaust pipe for an HVAC system. Evaluation by a qualified contractor is recommended.

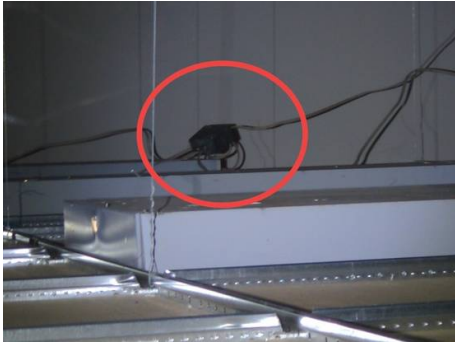
Electrical

Loose wiring was noted

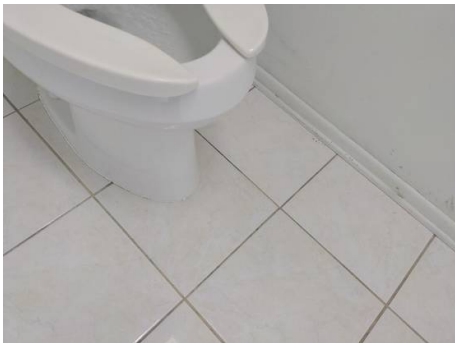
The toilet was loose at the floor and may require replacement of the wax seal
Water continued to run after flushing

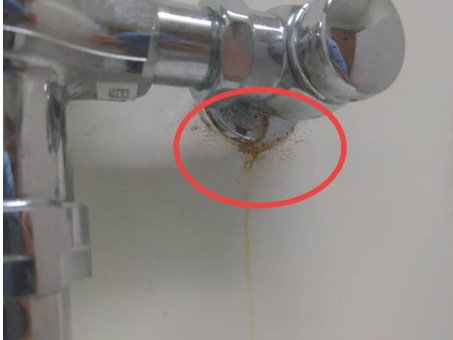
Urinals

Corrosion and possible leaking noted

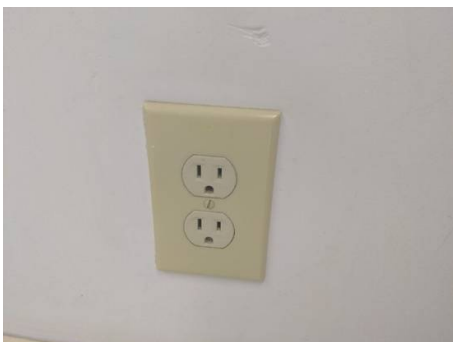
Non-GFCI outlet noted near water source - But was connected to a GFCI circuit

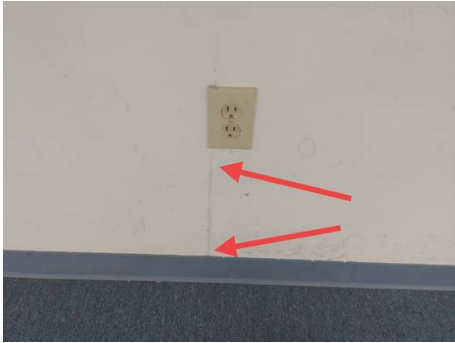
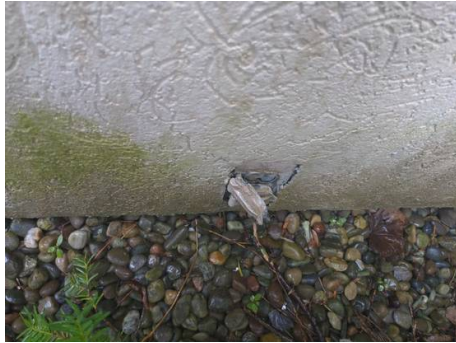
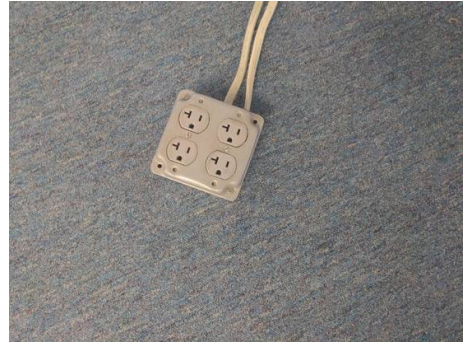
Loose outlets were present

Moisture was present in some areas of the walls, and indications of moisture were present around some outlets. Most notably on the side wall in the main room. Evaluation by qualified electrician is recommended.

An exterior outlet was located on the front of the building, and was not live at the time of inspection. The outlet was damaged, and too close to the ground. It also showed signs of moisture intrusion.

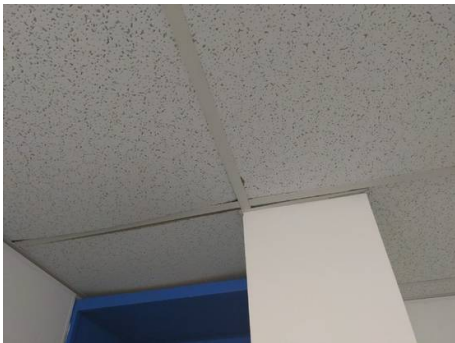
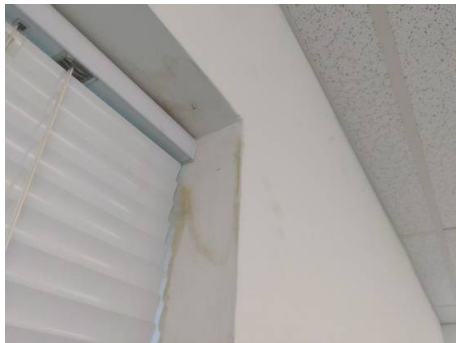
Moisture stains, surface damage, and loose and curled tiles were present

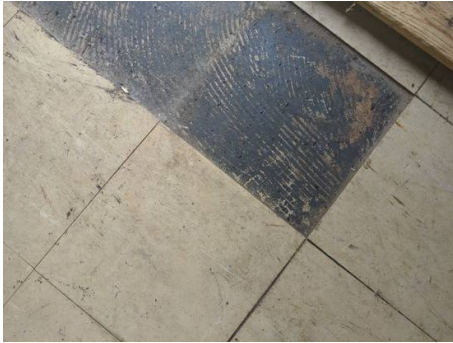
Floors

Nine-inch tile present and could contain asbestos. This is not an asbestos inspection and no testing was done to determine if the material was asbestos. Evaluation by a qualified asbestos specialist is recommended.

Surface damage noted

Cracked tile was present

Loose flooring was present

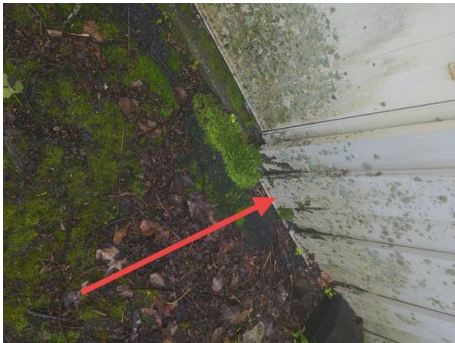
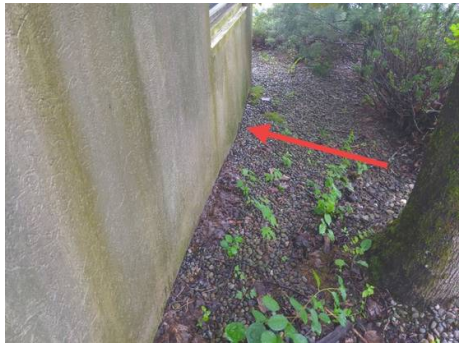
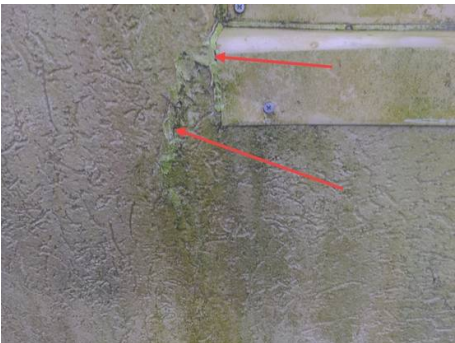
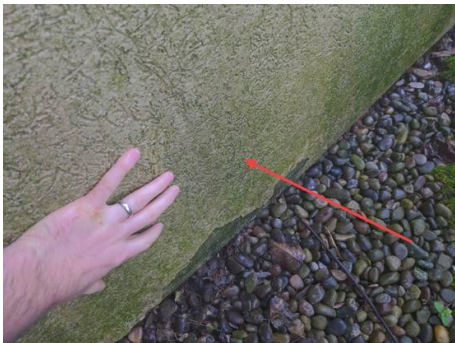
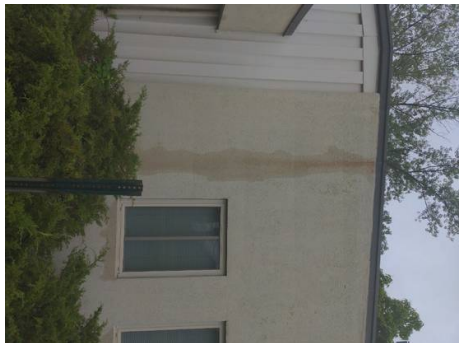
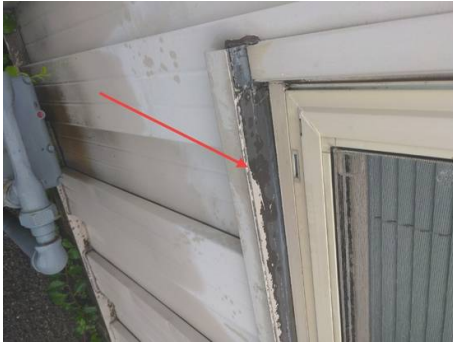
The building appeared to be constructed of insulated panels and steel frame construction. Evidence of active water intrusion into the panels was found in multiple locations from flashing details around windows and door and fascia transitions. Evidence of water intrusion was found on interior walls as well as around window and door frames. Once panels get wet they may not be able to properly dry and internal damage was likely present that would only be

discovered with intrusive investigation beyond the scope of this inspection so profession evaluation is recommended by contractors that represent you.

EIFS siding was present on parts of the building and was loose, damaged, and showed signs of moisture intrusion- EIFS exterior finishes are prone to water infiltration and may cause hidden damage to the structure. There is usually no visible evidence of such damage. We recommend a detailed inspection by a qualified specialist.

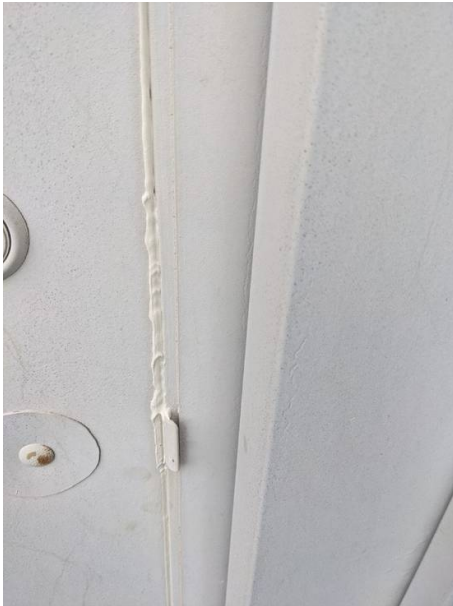
Entry Doors

Hazardous

Side exterior door was sealed off a time of inspection. A proper direct emergency egress was not able to be found and is a safety issue

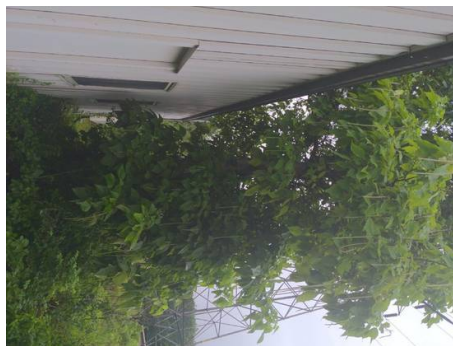
Vegetation

Possible Major Concern

Recommend keeping vegetation away from the structure(s)
Trees and vegetation were notably close to the building. The roots, branches, and other vegetation appear to be causing issues, and unseen damage likely exists. Recommend evaluation by qualified contractor.

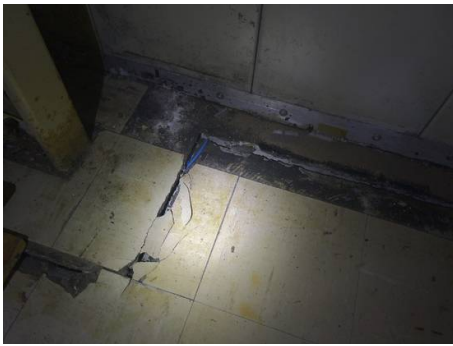
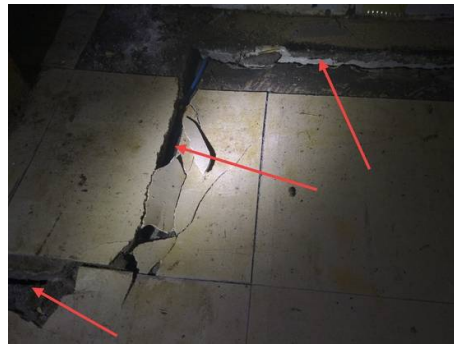
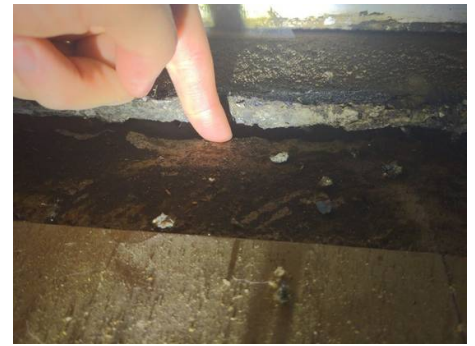
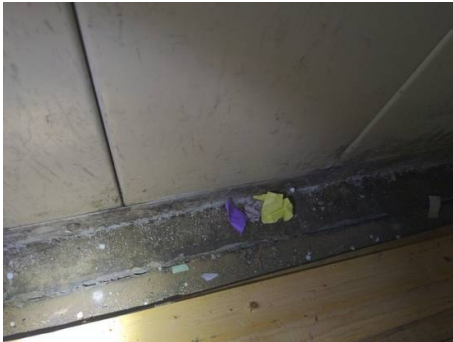
Indications of movement were noted in the slab/supports at the rear of the building. The gaps and indications of movement that were noted were outside of the normal range for a building of this type, and were also at an area with a large tree that was close to the building.
Evaluation of this structure by a qualified structural engineer is recommended

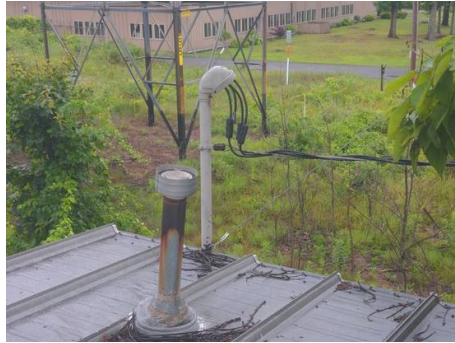
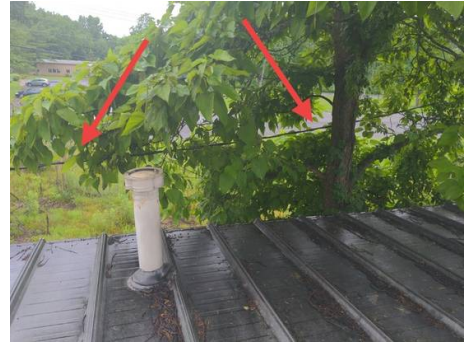
Electrical
Main Service Drop/Entry
Hazardous

The main service line was too close to a tree, and the main drop was very close to an exhaust pipe for an HVAC system. Evaluation by a qualified contractor is recommended.

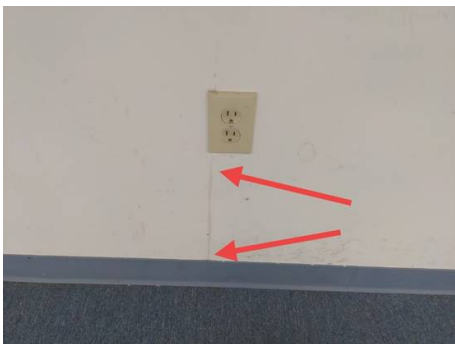
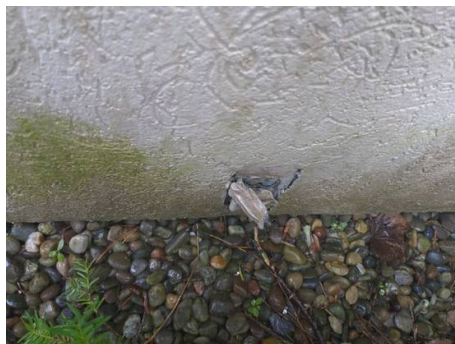
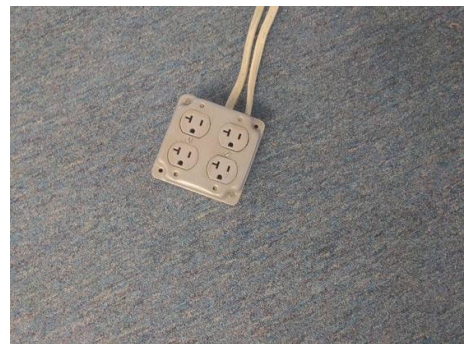
Electrical

Hazardous

Loose outlets were present
Moisture was present in some areas of the walls, and indications of moisture were present around some outlets. Most notably on the side wall in the main room. Evaluation by qualified electrician is recommended.
An exterior outlet was located on the front of the building, and was not live at the time of inspection. The outlet was damaged, and too close to the ground. It also showed signs of moisture intrusion.

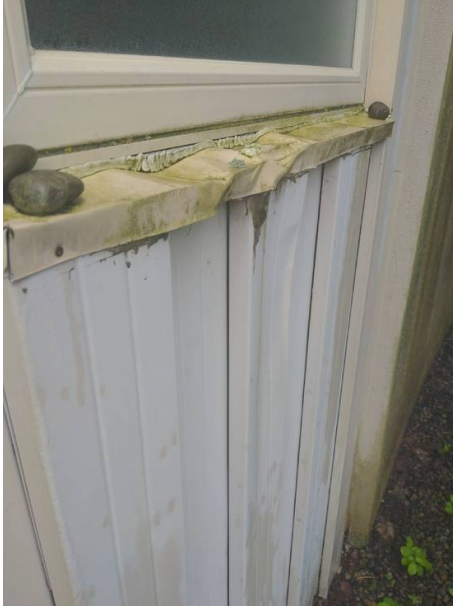
Trim, Siding, Fascia

Marginal

Heavily damaged - see main siding notes

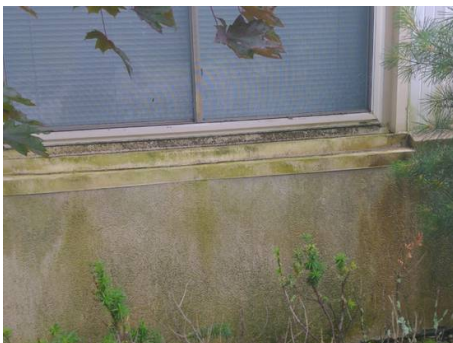
Windows

Marginal

Some windows had hard operation. Damage was also noted around several windows - see main exterior siding notes

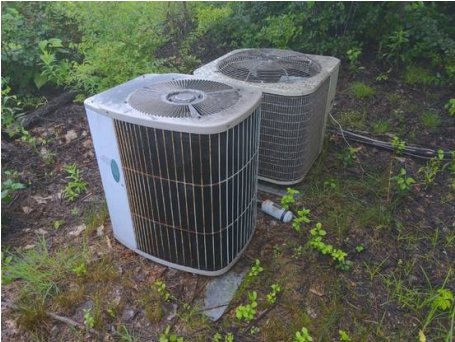
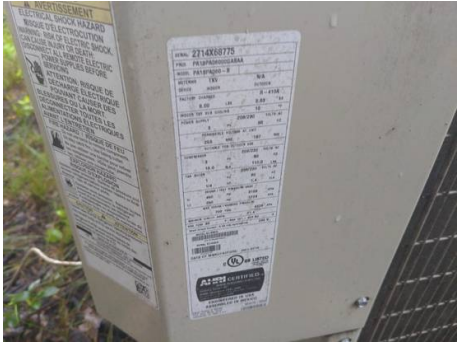
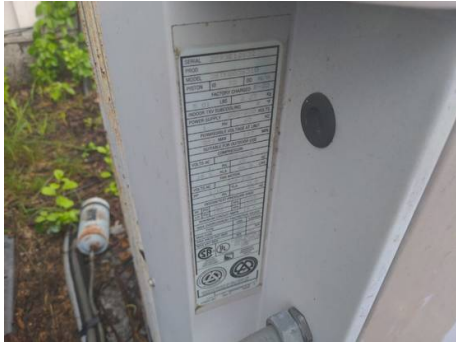
Marginal

The exterior units were notably deteriorate and in need of maintenance by qualified professional

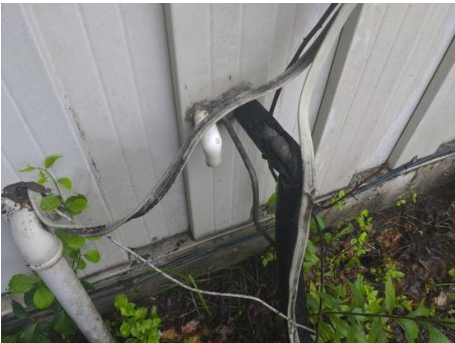
Condensation Removal

Condensation removal did not discharge far enough away from the building

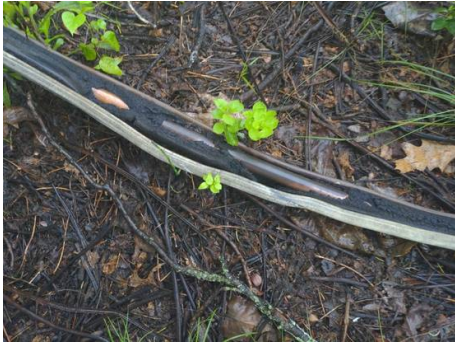
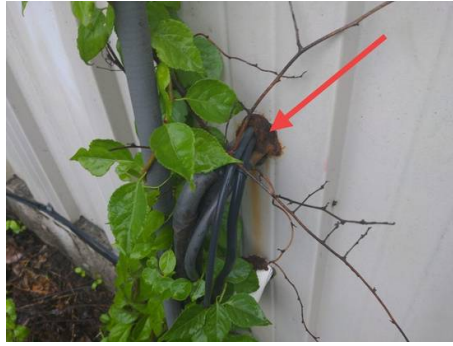
Refrigerant Lines

Deteriorated insualtion noted at refrigerant lines
Unsealed entry point of refrigerant lines into the home

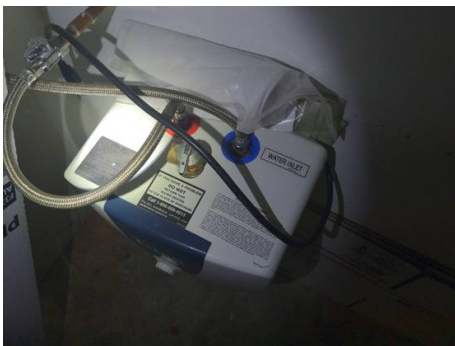
Water heater was not on at time of inspection and was not able to be tested.
Missing drain tube at TPRV

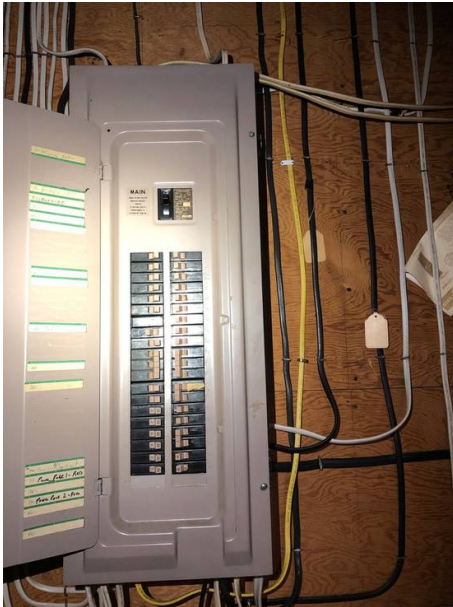
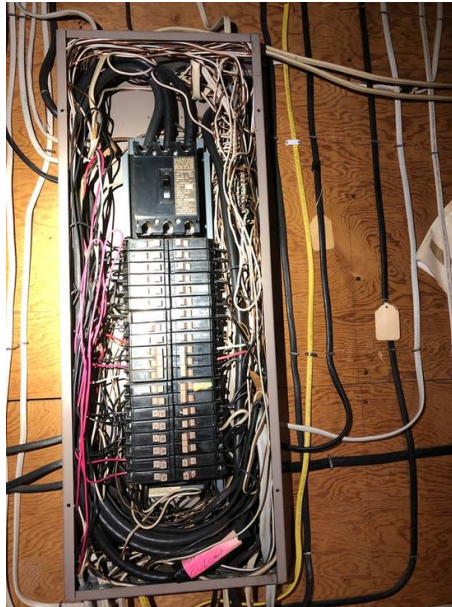
Electric Panel

Screws with pointed tips were used that should be replaced with proper electrical screws so the wires are not penetrated and the dead front cover is removed.

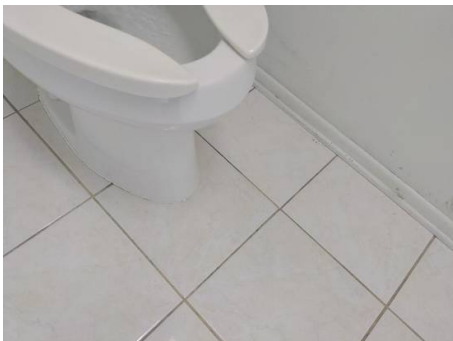
Toilets

The toilet was loose at the floor and may require replacement of the wax seal
Water continued to run after flushing

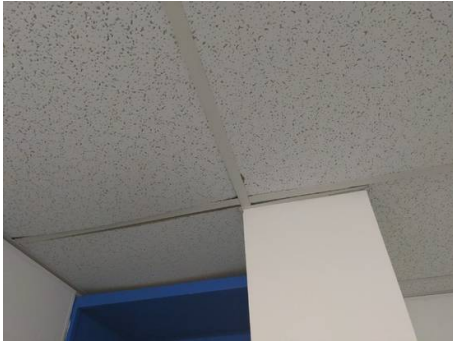
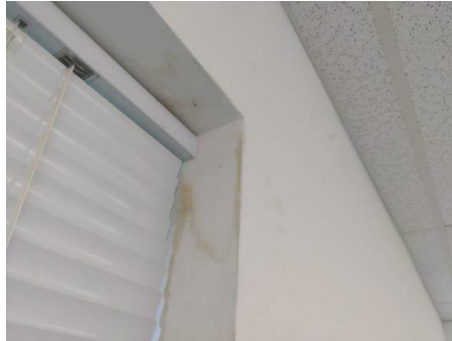
Moisture stains, surface damage, and loose and curled tiles were present

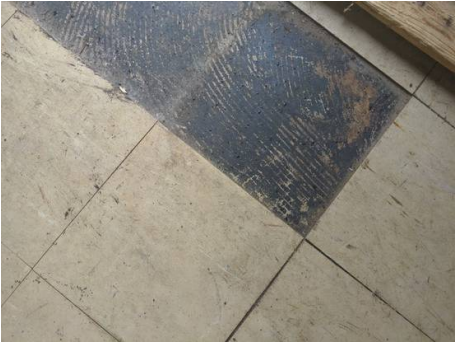
Floors

Surface damage noted

Cracked tile was present

Loose flooring was present
